FRACTURE TOUGHNESS AND MICROSTRUCTURAL STABILITY OF HEAVILY DEFORMED TUNGSTEN MATERIALS

Vladica Nikolić

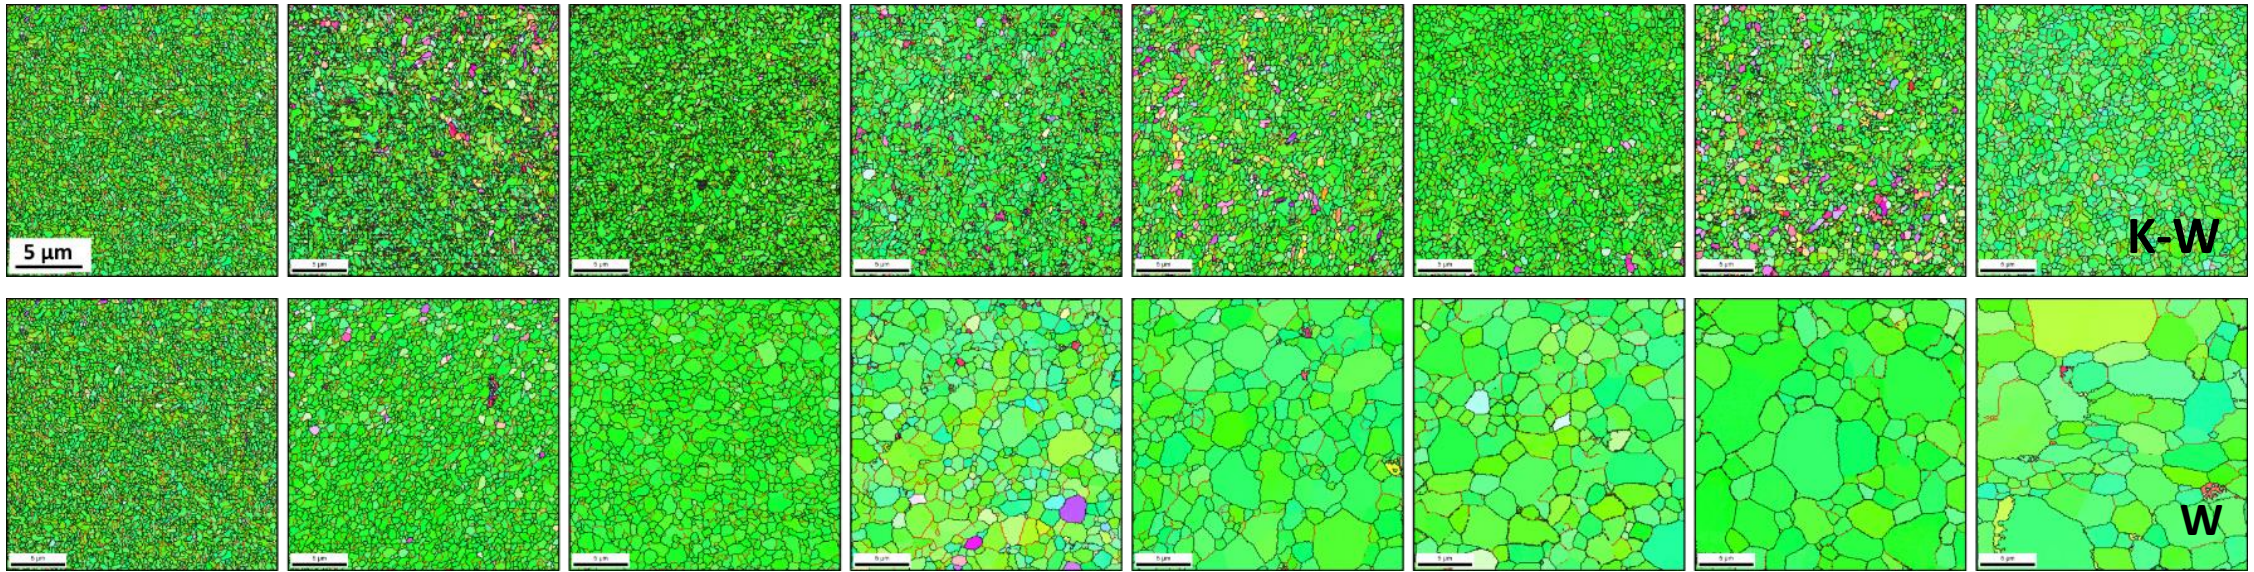
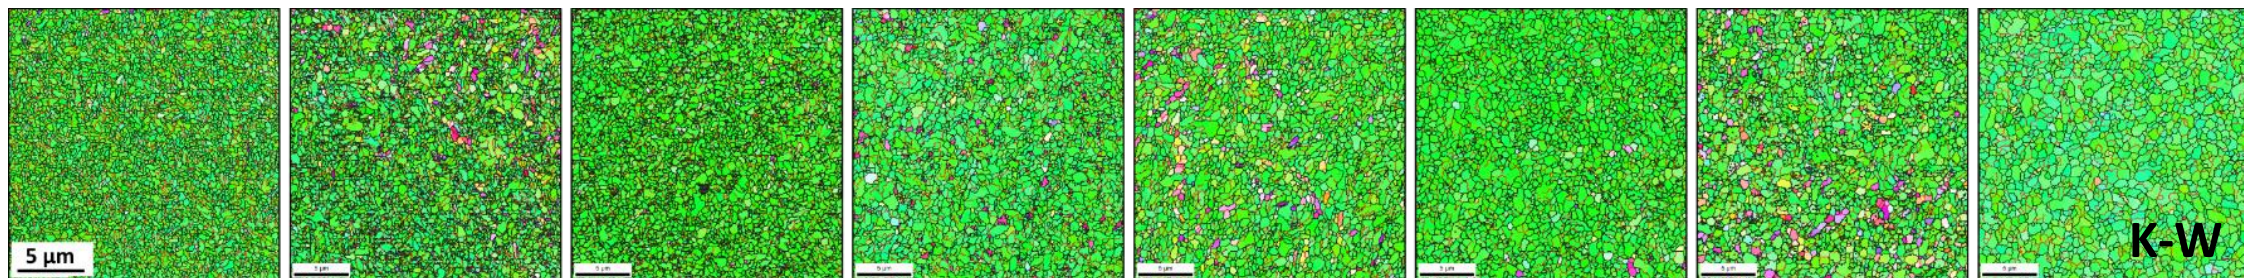
as received

900°C

1100°C

1200°C

1300°C

1400°C

1500°C

1600°C

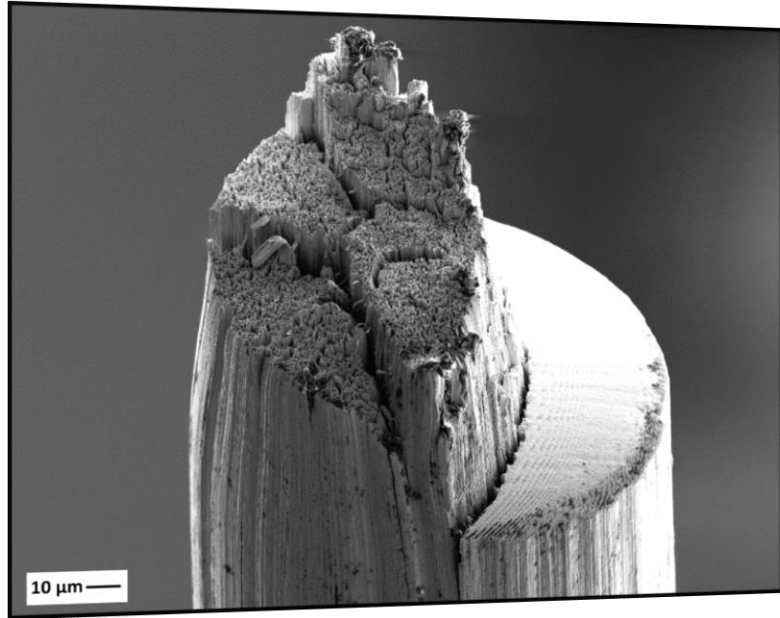
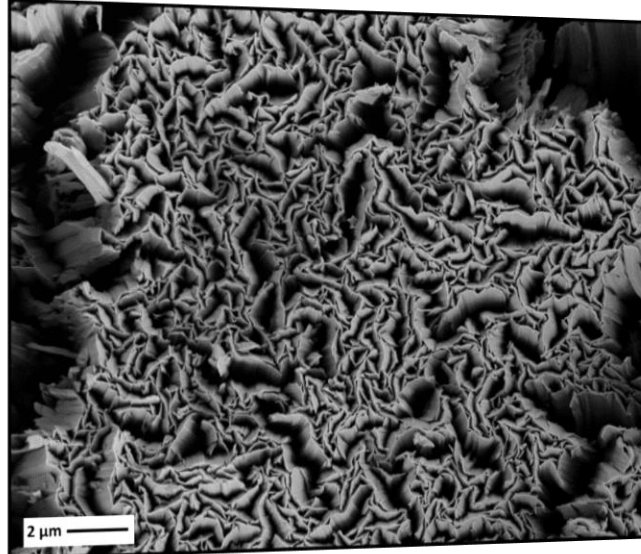
ductile

brittle

DBTT ~ RT !
