# Plasma Cleaning of Steam Ingressed ITER FMs

K. Soni<sup>1</sup>, L. Moser<sup>1</sup>, L. Marot<sup>1</sup>, R. Steiner<sup>1</sup>, F. Le Guern<sup>2</sup>, J. Piqueras<sup>2</sup> and E. Meyer<sup>1</sup>

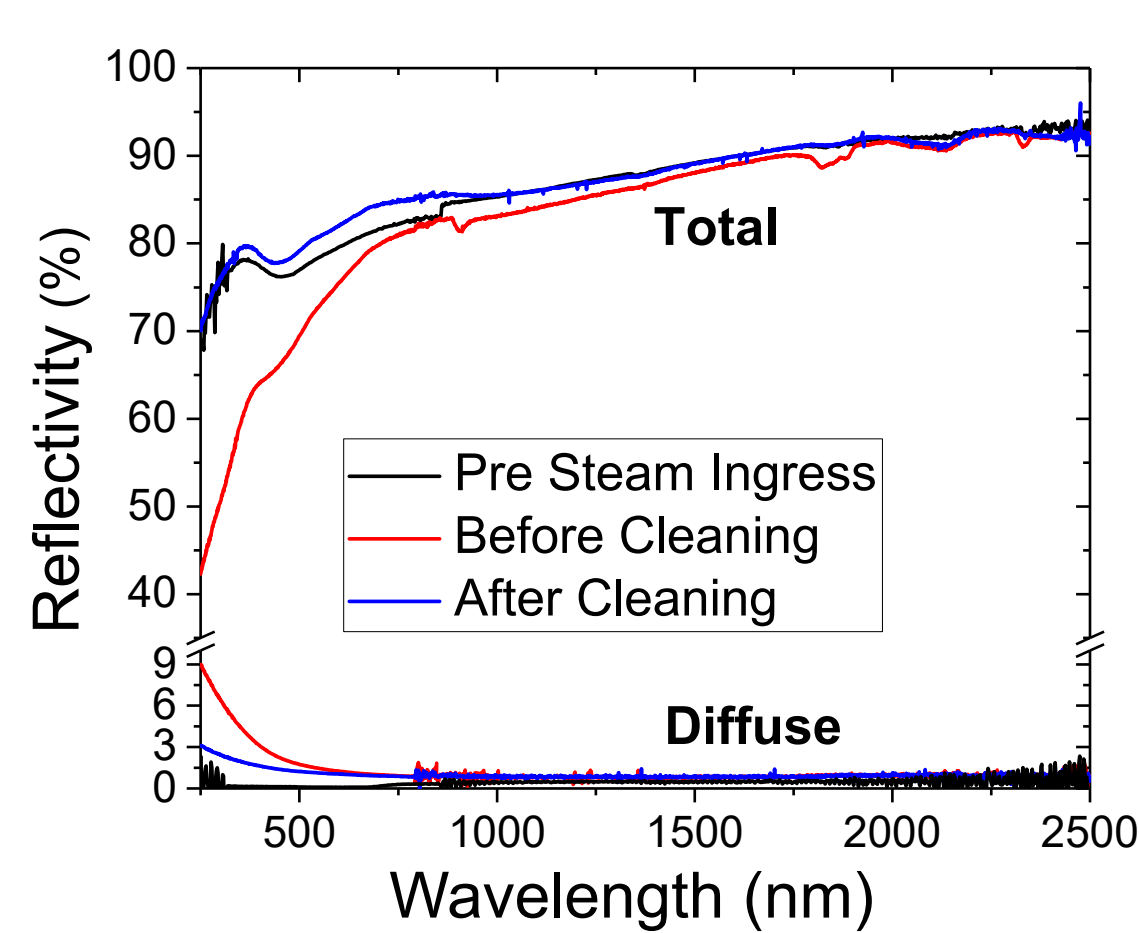
- Cleaning in Ar plasma with 13.56 MHz, 0.5 Pa at 200 V for 8 hours

- Total reflectivity recovered
- Diffuse reflectivity decreased
- Removal of Rh oxide

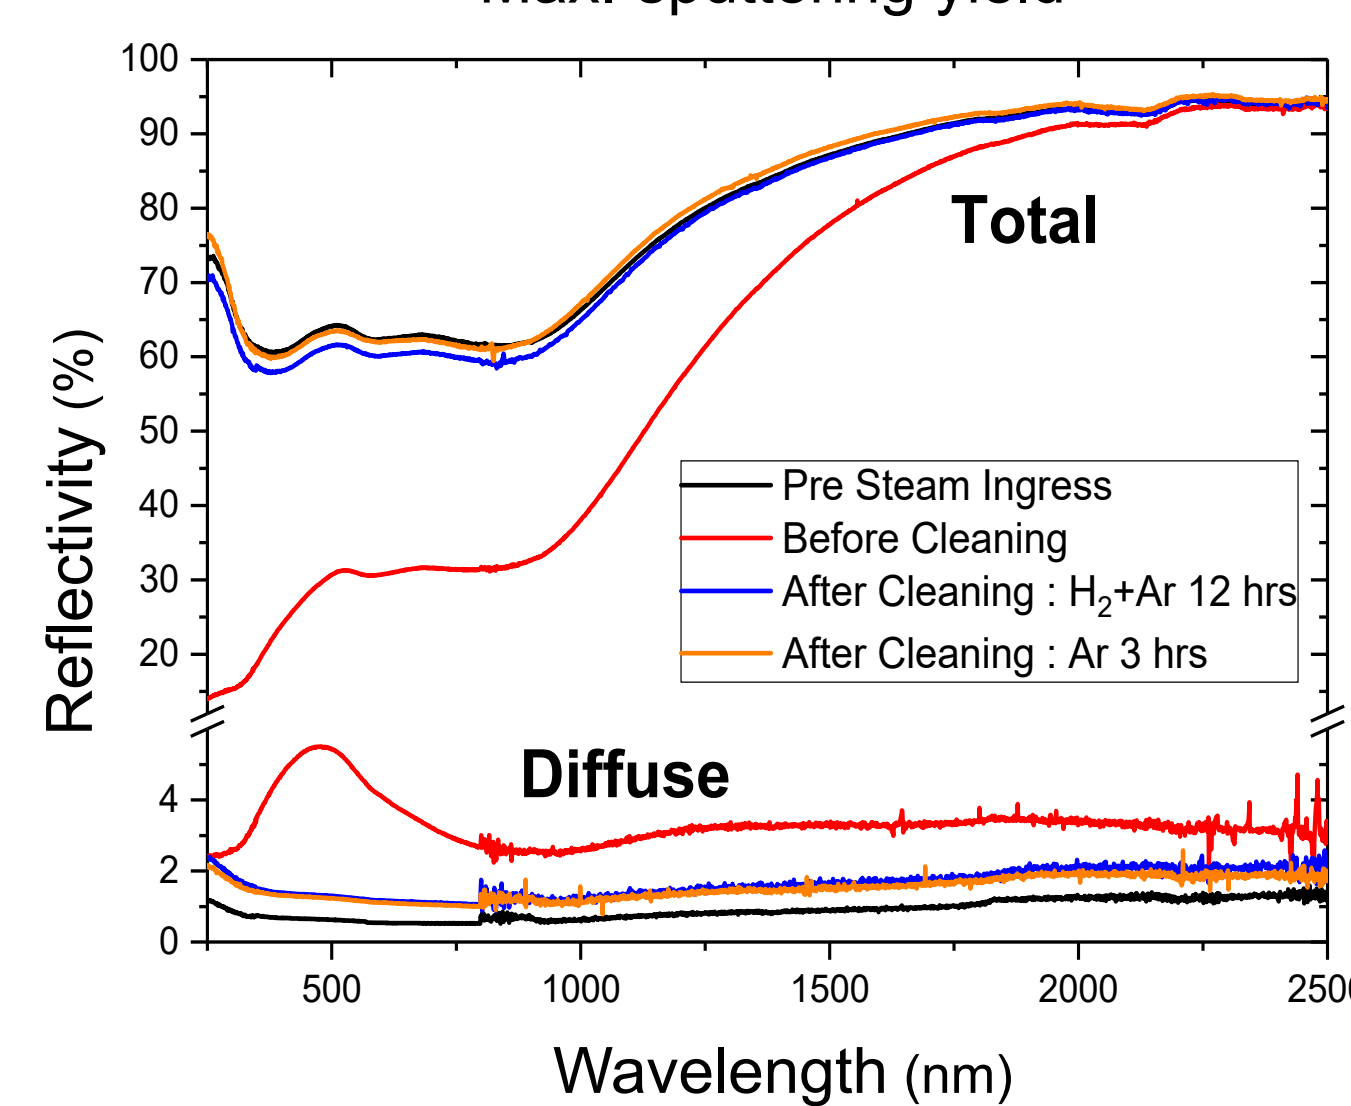
- Cleaning done in 3 steps (13.56 MHz, 0.5 or 1 Pa at 200V)

1. H<sub>2</sub> plasma cleaning
  - Chemical sputtering
  - Ineffective because of low sputtering yield
2. H<sub>2</sub>+Ar (1:1) plasma cleaning
  - Ar added for higher sputtering yield
3. Ar plasma cleaning
  - Max. sputtering yield

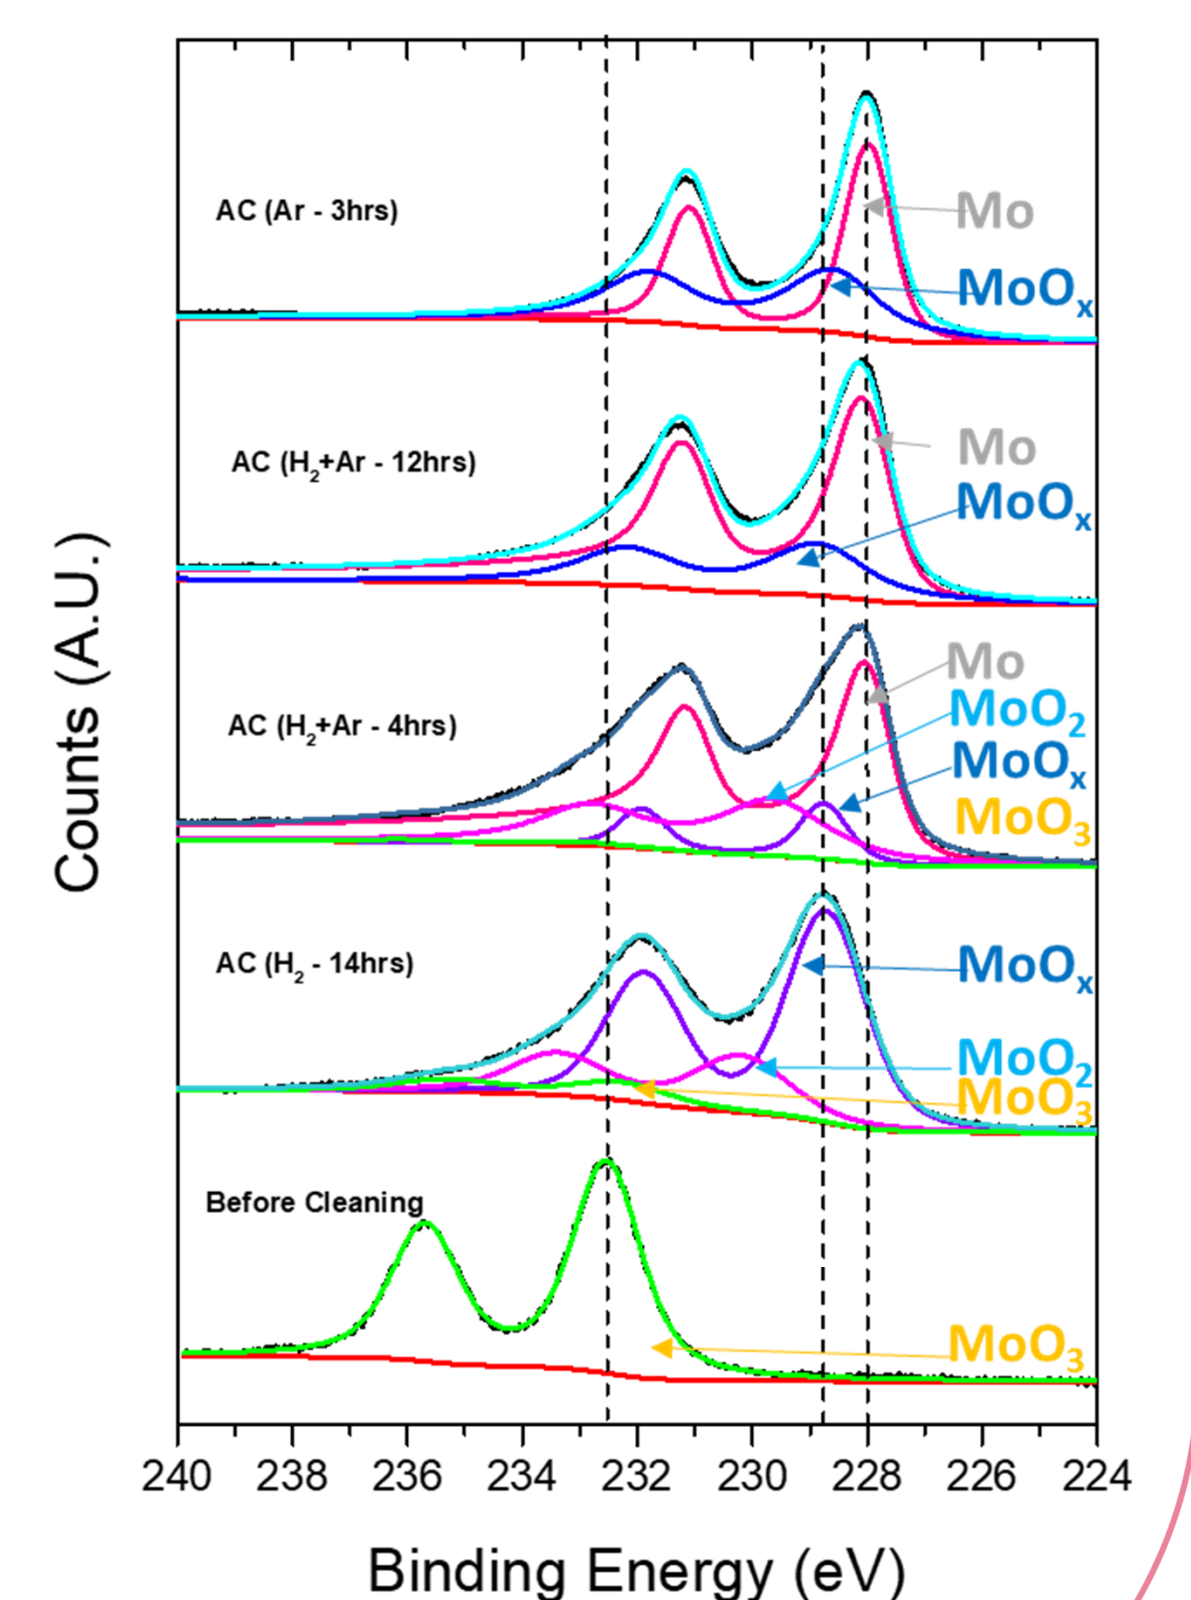
- Total reflectivity recovered
- Diffuse reflectivity decreased
- Removal of Mo oxide
